Belo Horizonte - Minas Gerais

Extreme Weather Event:

Torrential Rain
Period: March 6-7, 2026

COOPESOL LESTE

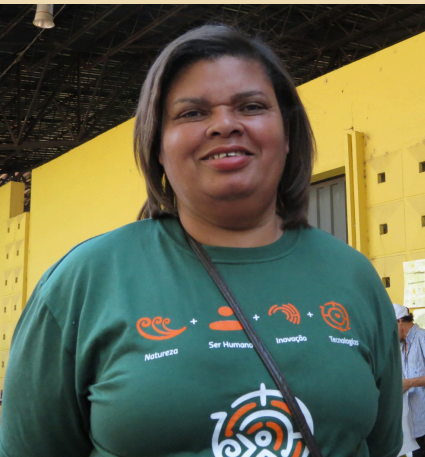
“My concern today is with the heavy rain coming. The warehouse keeps flooding, we have several cracks in the walls (...). My concern is that everything seems normal, but we don’t know what’s happening underground. It looks fine, but a tragedy could happen. Does something bad have to happen before action is taken?”
